BLIND-SPOT CAMERA SYSTEM

side mirror mounted electronic visual assist system for enhanced driver awareness

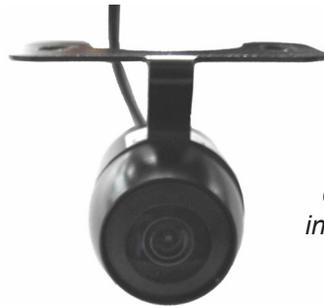
GT-2202SV

mini bullet camera
surface mount - butterfly bracket or silicone pod (included)

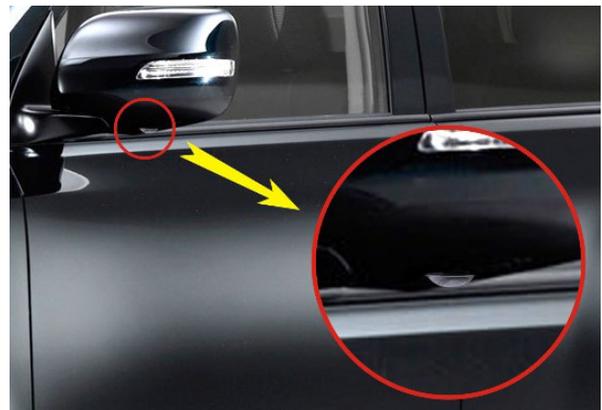
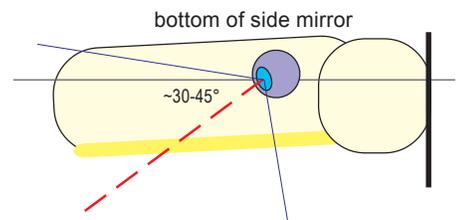
mount cameras under mirrors
to point at the blind spot zones

Point lens ~30-45° rearward from the line perpendicular to the vehicle body for ideal blind spot coverage. Camera shows 120° field of view.

IMPORTANT TECHNICAL INFO: outside mirror glass and inner door panel removal is required to mount the camera and route the wiring. Please refer to factory service manual for proper mirror glass R&R procedure. Mirror removal tool, glazing stick and trim panel removal tool set recommended.
